HUGE

Clinical Case Collection

Chairside Clinical Solutions for
Everyday Dentistry

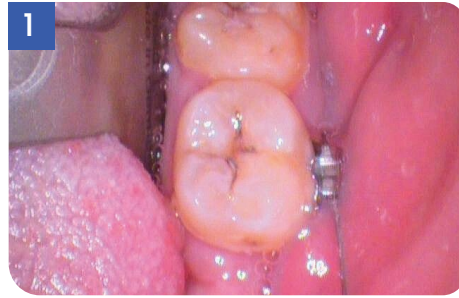
Pre-operative View
Initial clinical presentation of occlusal caries on tooth #36.

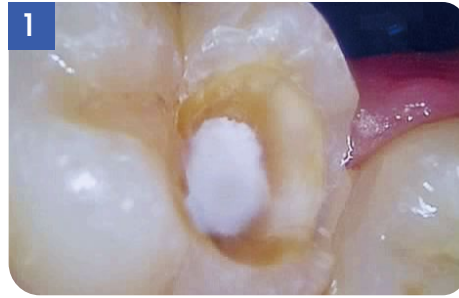
Tooth Preparation

Defective restoration and caries removed; margins refined and slight bevel created using fissure and round burs.

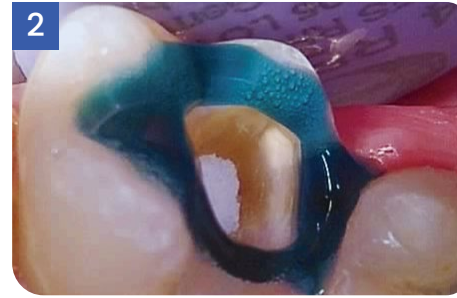
Selective Etching

Enamel selectively etched with P-Etchant for 20–30 seconds, rinsed and gently dried.

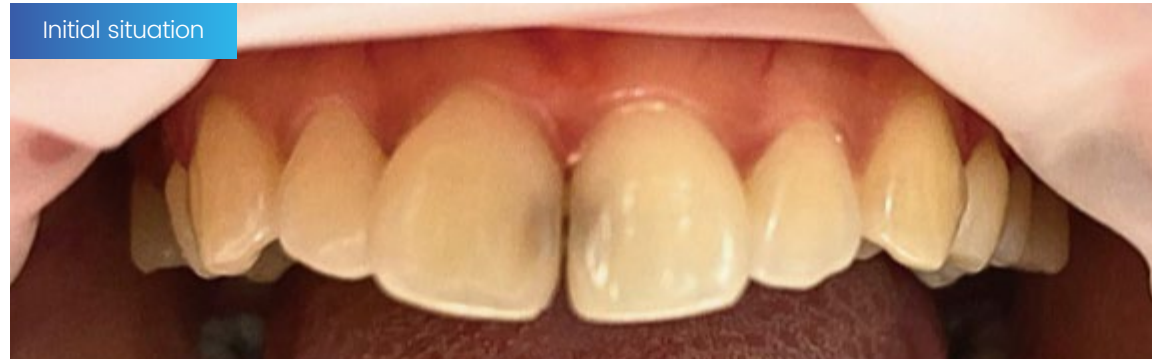
Initial situation

A 27-year-old female patient complained of spacing and visible discoloration between the maxillary central incisors. The patient requested an aesthetic restoration using direct composite.

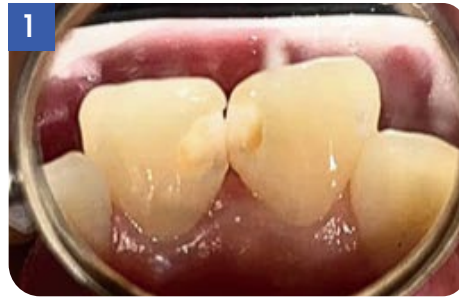
Tooth Preparation
Minimal removal of defective enamel margins and smoothing of edges.

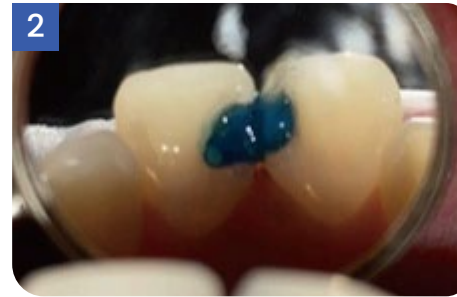
Etching
Enamel etching for 20-30s, dentin etching for 15s using P-Etchant.

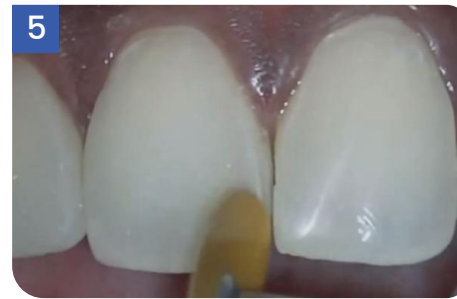
Finishing & Polishing
Refine morphology with fine diamond burs; achieve surface gloss with multi-step disc and rubber polishing system

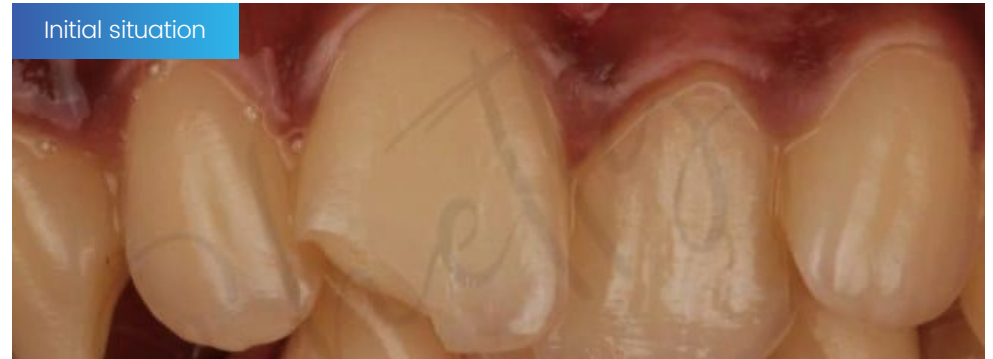
Initial situation

A 20-year-old male patient presented with a fractured maxillary right central incisor (#11) following minor trauma. Clinical examination revealed enamel and dentin involvement without pulp exposure, consistent with an Ellis Class II fracture. The tooth was vital and asymptomatic.

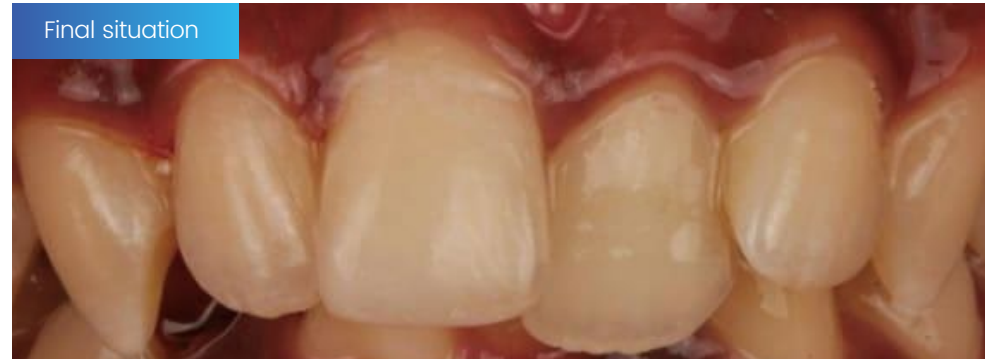
Final situation

Postoperative evaluation showed excellent shade matching, surface gloss, and marginal adaptation, achieving a highly aesthetic and functional result.

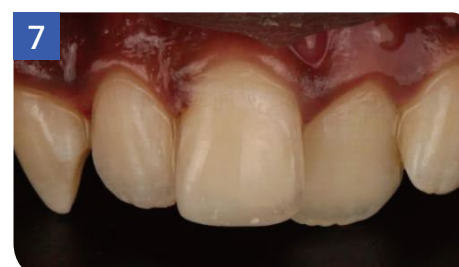
Final Finishing & Polishing
Final high-gloss polish completed to enhance enamel-like smoothness and longevity.

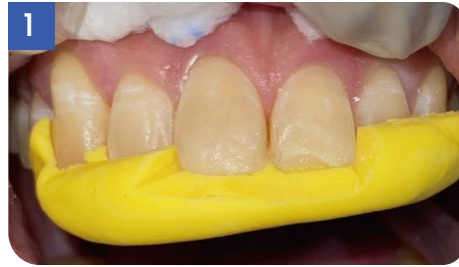
Pre-Preparation

Old composite on #11–#21 will be removed, and a long labial bevel was created to improve enamel bonding and achieve smooth shade transition. A putty index was used to guide palatal anatomy.

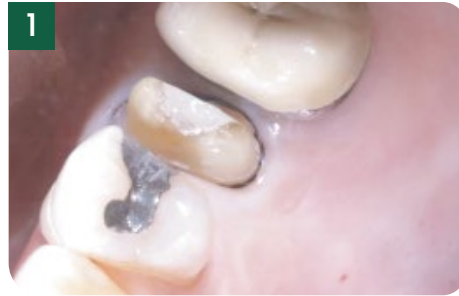
Tooth Preparation

The tooth was prepared for a full zirconia crown with proper occlusal and axial reduction. A clean, continuous finish line was created to support accurate seating and margin quality.

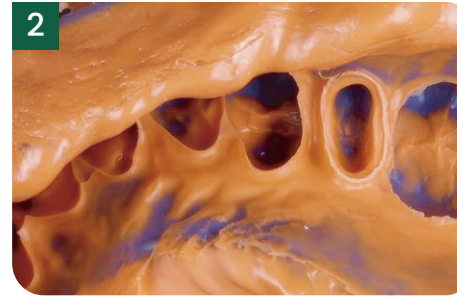
Final Impression

One-step impression technique was performed using PERFIT Putty and PERFIT Light Body simultaneously. The putty provided the bulk and stability, while the light body captured detailed margins and surface texture in a single impression, ensuring high accuracy for the zirconia crown fabrication.

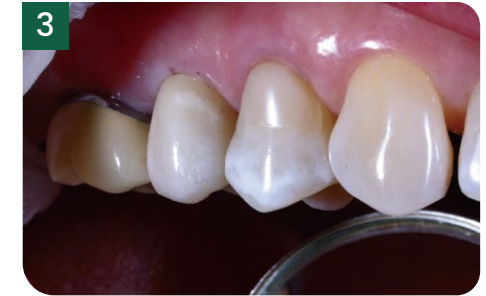
Self-Etch Bonding & Cementation

HugeBond Universal FliPro was applied using the self-etch technique, allowing the adhesive to condition and infiltrate the tooth surface without separate phosphoric acid etching. After uniform application and light curing, the zirconia crown was cemented using TopCEM DCRC dual-cure resin cement to achieve strong retention and complete polymerization.

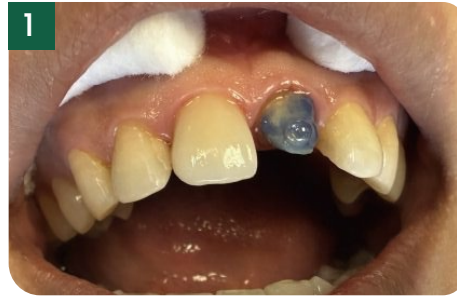
1 Tooth Preparation & Etching

The prepared tooth surfaces were etched with P-Etchant to prepare an optimal bonding substrate.

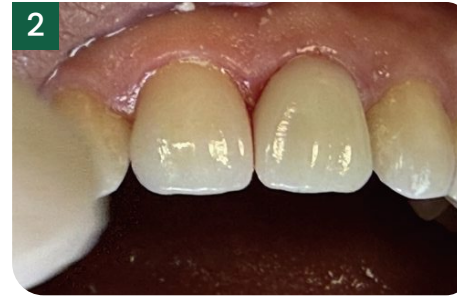
2 Try-In Shade Adjustment

A custom try-in shade was created by mixing two-thirds TopCEM DCRC A2 with one-third TopCEM DCRC A3 to evaluate the color match and achieve a natural transition with the adjacent tooth.

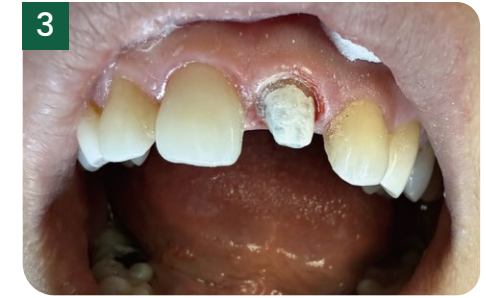
3 Cleaning and Adhesive Application

After the try-in, the restoration was removed and cleaned. HugeBond Universal FliPro adhesive was applied to the tooth to promote reliable bonding.

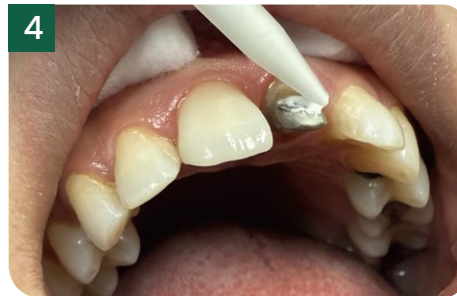
4 Cementation and Shade Masking

TopCEM DCRC (White Opaque) was applied selectively to mask the dark stump and maintain consistent final color.

Final cementation was then performed using the previously adjusted A2/A3 cement, which was placed on both the tooth and the internal surface of the crown before accurate seating.

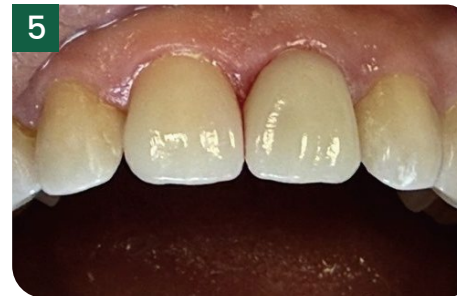
5 Finish and Polish

A brief tack cure allowed removal of excess cement, followed by light-curing from each side for 20 seconds to complete polymerization. After curing was completed, the margins were refined and the restoration was polished for a smooth, natural finish.

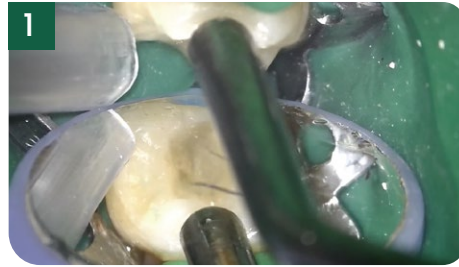
Isolation and Access Refinement
Rubber dam isolation was applied for moisture control. The access cavity was cleaned to remove residual debris and expose sound dentin surfaces for adhesive procedures.

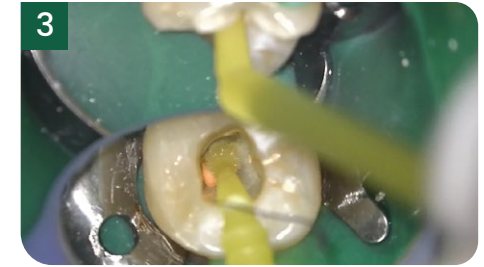
Adhesive Application
HugeBond Universal FilPro was applied to the cavity walls, evenly dispersed with gentle air, and then light-cured to achieve reliable bonding.

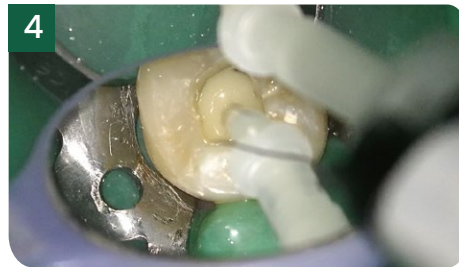
Core Build-Up
A dual-cure core build-up material UltraCore (HUGE) was injected and shaped anatomically. The dual-curing mechanism ensured complete polymerization throughout the core.

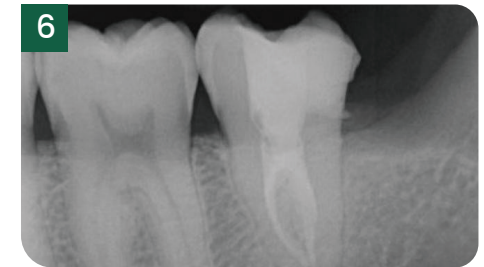
Post-Operative
A postoperative periapical radiograph was taken to evaluate the core build-up. The UltraCore material exhibited excellent radiopacity, allowing clear visualization of its margins within the access cavity.

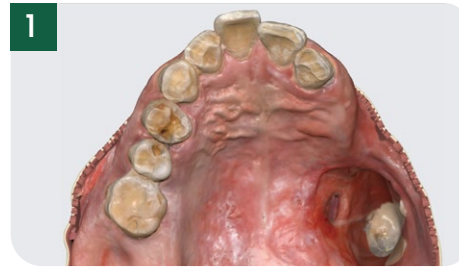
Intraoral Scan & Digital Planning
Intraoral scanning was performed. Teeth 16 and 15 were digitally removed and a 3D model was printed to simulate the post-extraction condition.

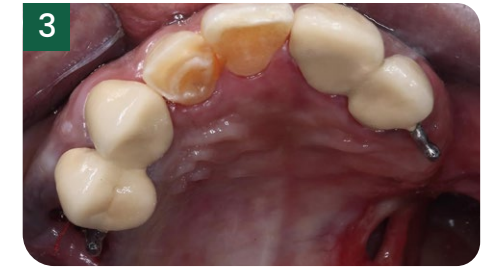
Try-in & Extraction
The PFM splints were tried-in, followed by extraction of 16 and 15.

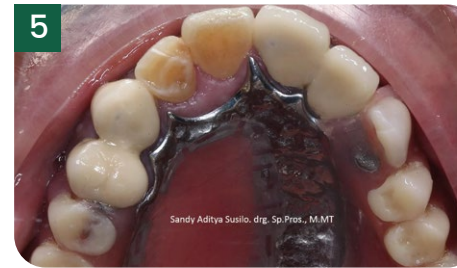
Framework Design & Obturator Fabrication
Denture borders were outlined, ensuring peripheral and palatal seal. The removable metal framework and acrylic teeth were fabricated based on the silicone impression.

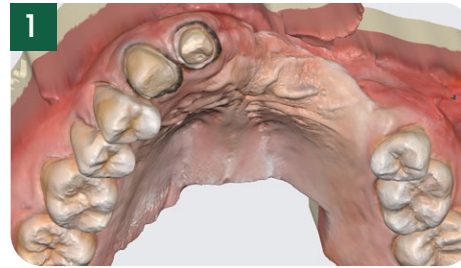
1 **Tooth Preparation & Intraoral Scan**
Tooth preparation and intraoral scanning were completed for teeth 13 and 12.

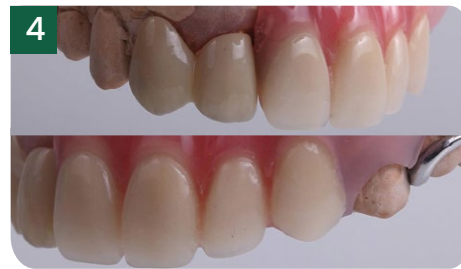
4 **Removable Denture Fabrication**
Removable metal framework and acrylic teeth fabricated based on the silicone impression.

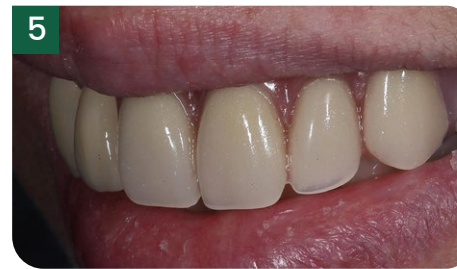
5 **Hybrid Denture Insertion**
The fixed splint on 13 and 12 integrates seamlessly with the removable denture featuring a thermosens clasp, achieving a natural and harmonious appearance.

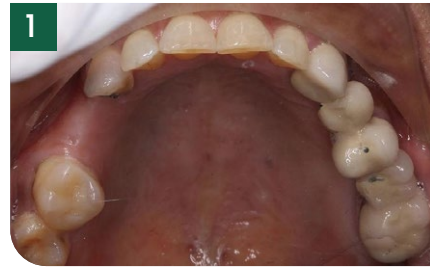
1 Clinical Stabilization

Root canal retreatment was performed on all infected teeth, followed by core reconstruction to provide sufficient stability before definitive prosthetics.

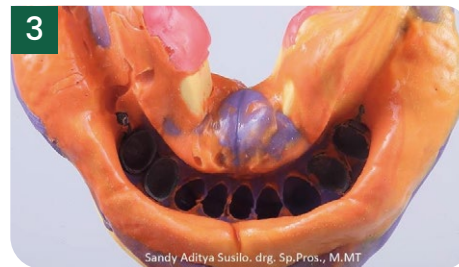
3 Lower Arch Fixed Splint + Attachment

Prepare 45, 44 | 33, 34 for fixed splint with distal male attachments. First final impression; after try-in, take a pickup impression for the lower hybrid denture metal framework.

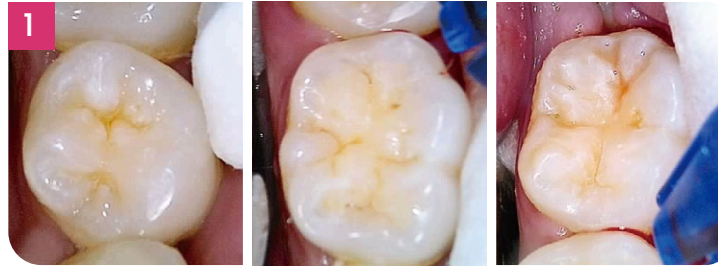
Tooth Preparation

The occlusal surfaces were polished with a brush and paste, followed by stain removal using a dental air polisher to ensure the fissures were completely clean.

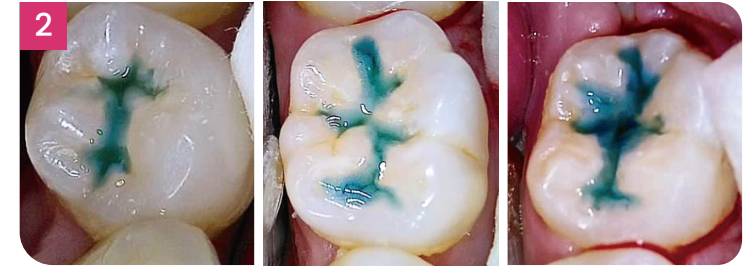
Etching

P-Etchant was applied for 30 seconds to condition the enamel.

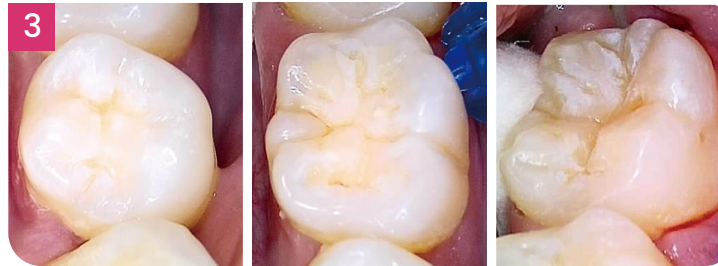
Post-etch Appearance

After rinsing and drying, the enamel surface appeared uniformly chalky white, indicating adequate etching for optimal resin bonding.

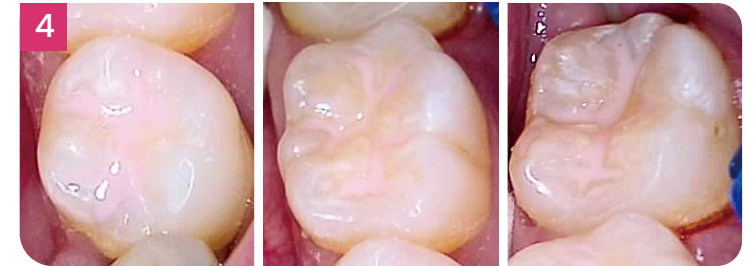
Sealant Application

Proseal F was applied over the etched fissures. Its low viscosity allowed deep penetration, and the pink color improved visibility. The material was gently spread to avoid bubbles, then light-cured for 15 seconds per tooth.

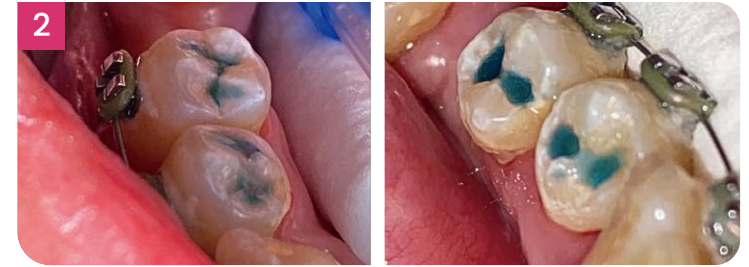
Etching

P-Etchant was applied for 30 seconds with good handling control. After rinsing and drying, the enamel showed a uniform chalky-white appearance, indicating proper etching for resin bonding.

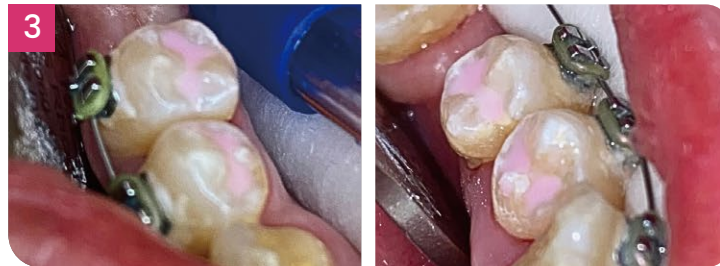
Sealant Application

Proseal F was applied into the etched fissures. Its low viscosity allowed deep penetration, while the pink color enhanced visual control. The material was spread evenly using a composite instrument to avoid bubbles and undercuts, then light-cured for 15 seconds per tooth.
